**STOL CH 801 STABILIZER ASSEMBLY – SECTION 4**  
**“INSTALLING FIBERGLASS TIPS”**

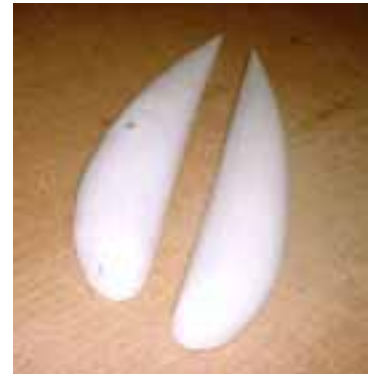
**FIBERGLASS H.T. TIP**  
**8H4-4**

The clecos in this photo are holding the tip rib 8H4-5 in place. Photo shows the left tip in the correct position for installation.

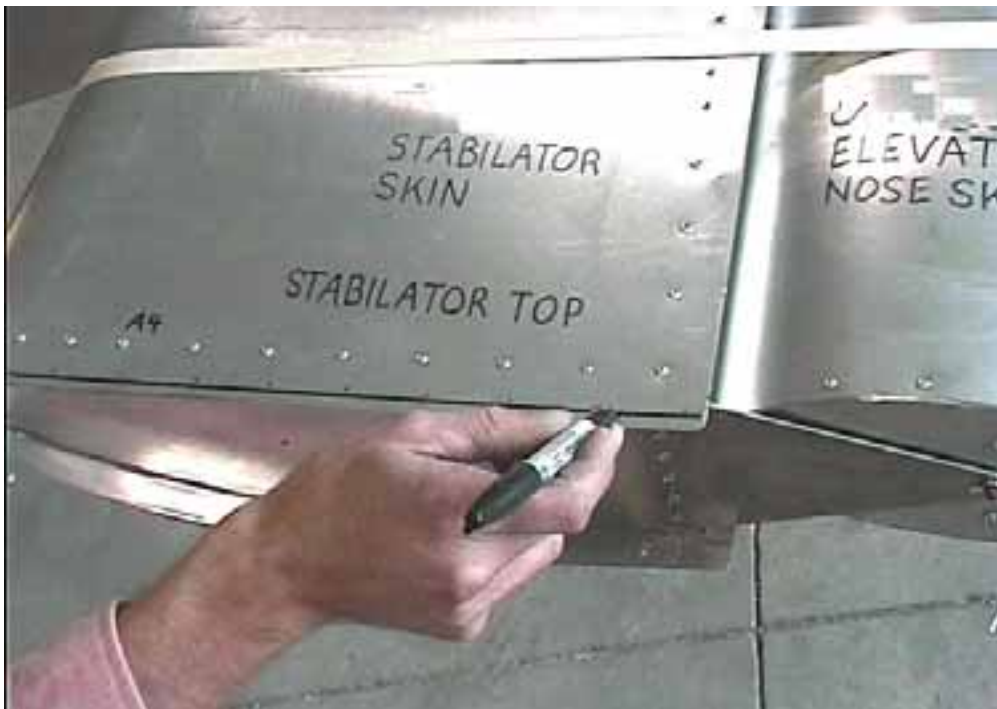
This work is best done with the elevator and horizontal tail installed on the aircraft.

Secure the elevator in a neutral position. Mark the rivet centerline on the tip and bottom skin 10mm in from the edge.

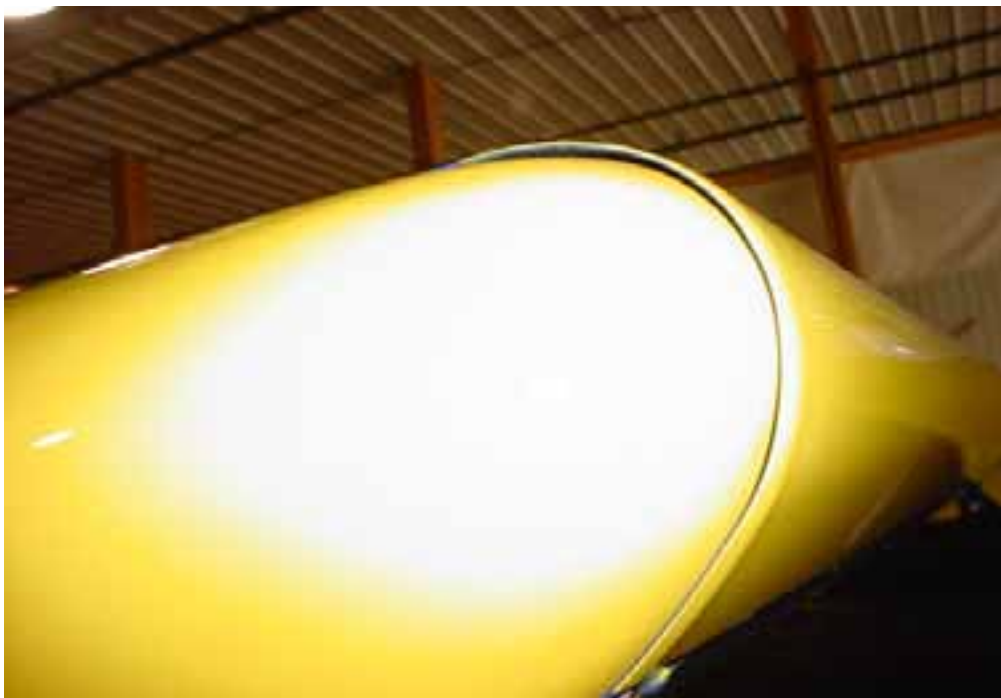
Push the fiberglass H.T. tip into the radius of the skin

Detail of right side.

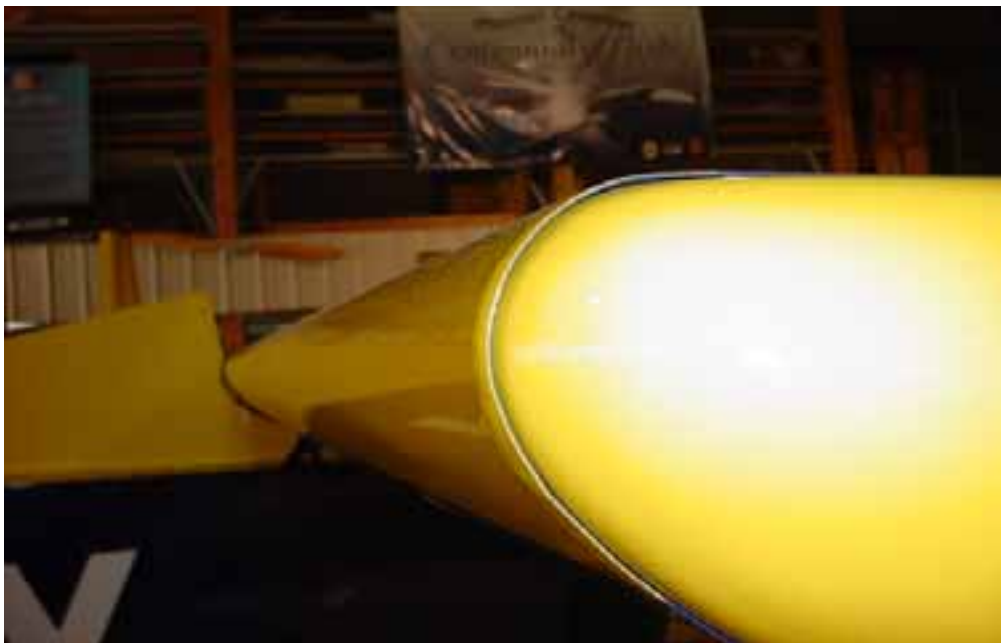
Small gap is acceptable.

Detail of the left leading edge

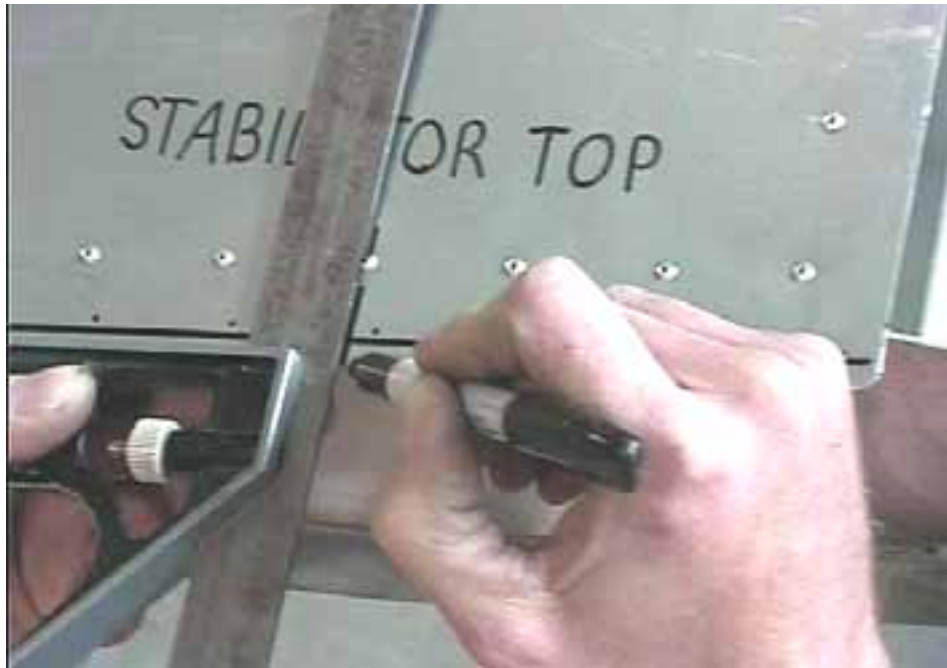
Extend the rivet centerlines as shown.

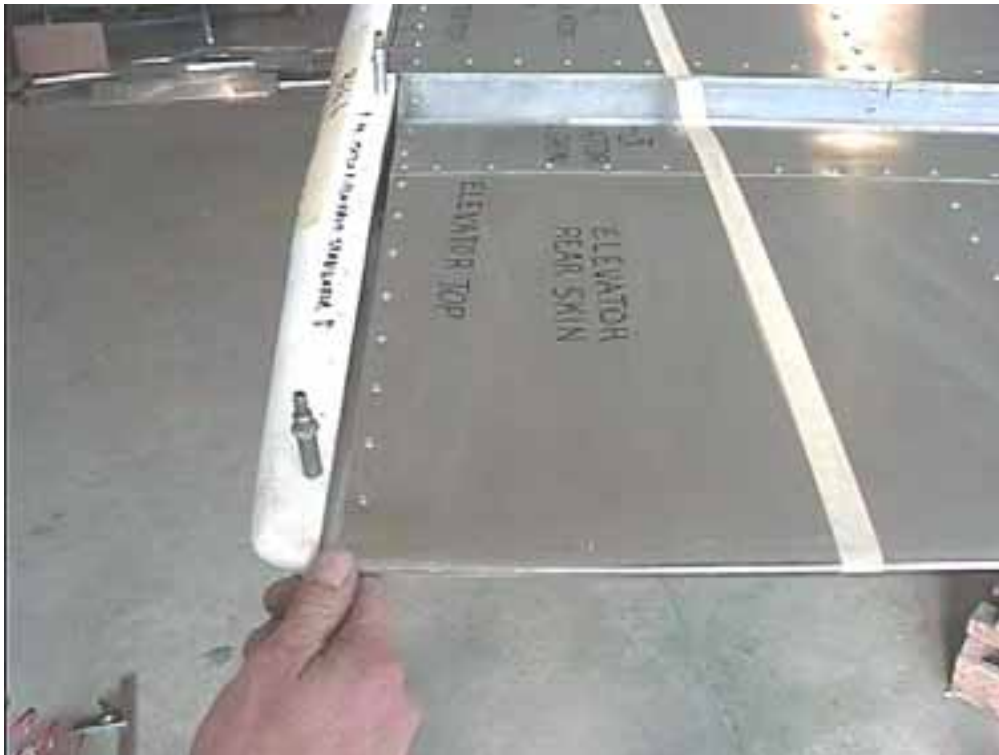
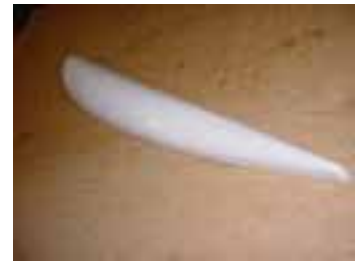
Fit the fiberglass tip keeping it level and its nose tight to the inside of the nose skin.

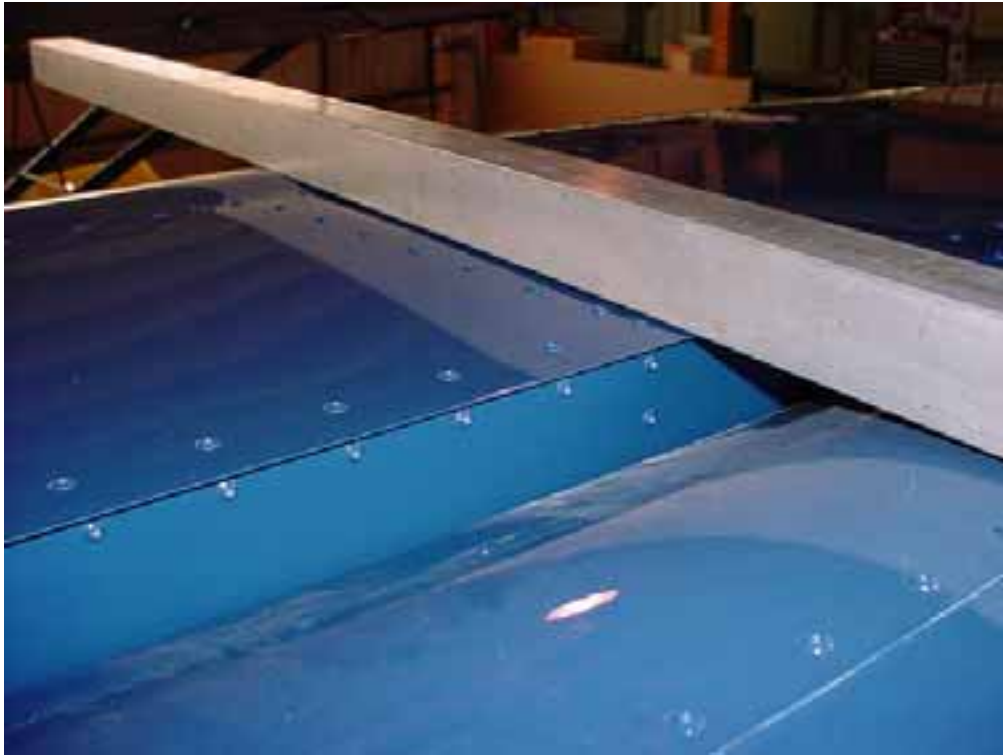
Straight edge on top of stabilizer to locate elevator neutral position

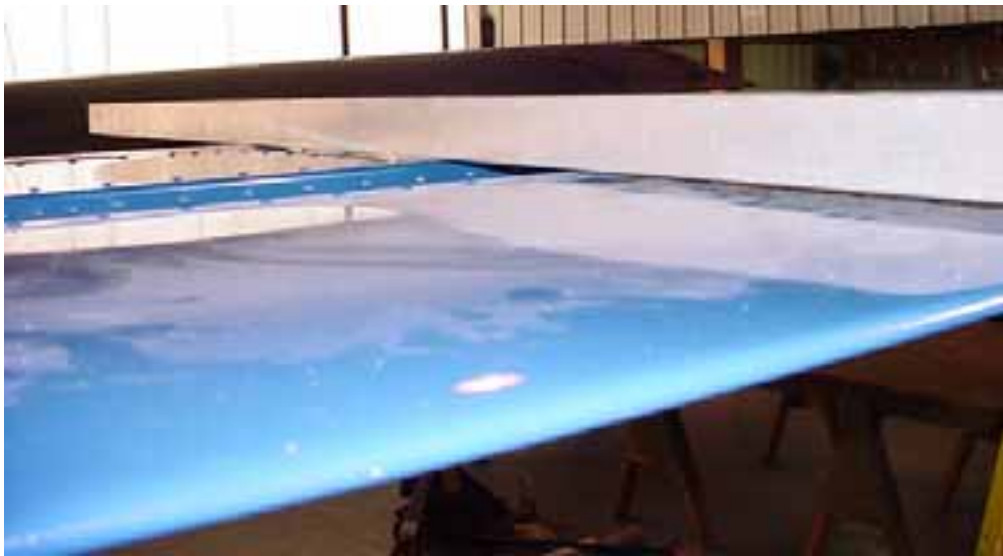
Elevator neutral position: lay a straight edge over the top of the stabilizer, bring the elevator to the straight edge.

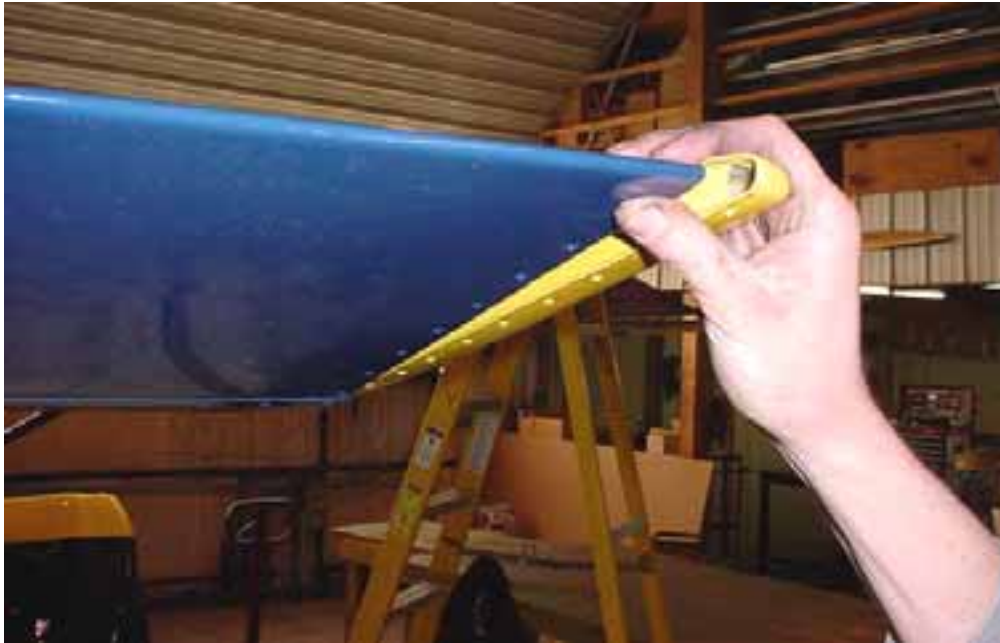
**CHECK:** Position the ends of the fiberglass tips in line with the trailing edge of the elevator (when elevator in neutral position).

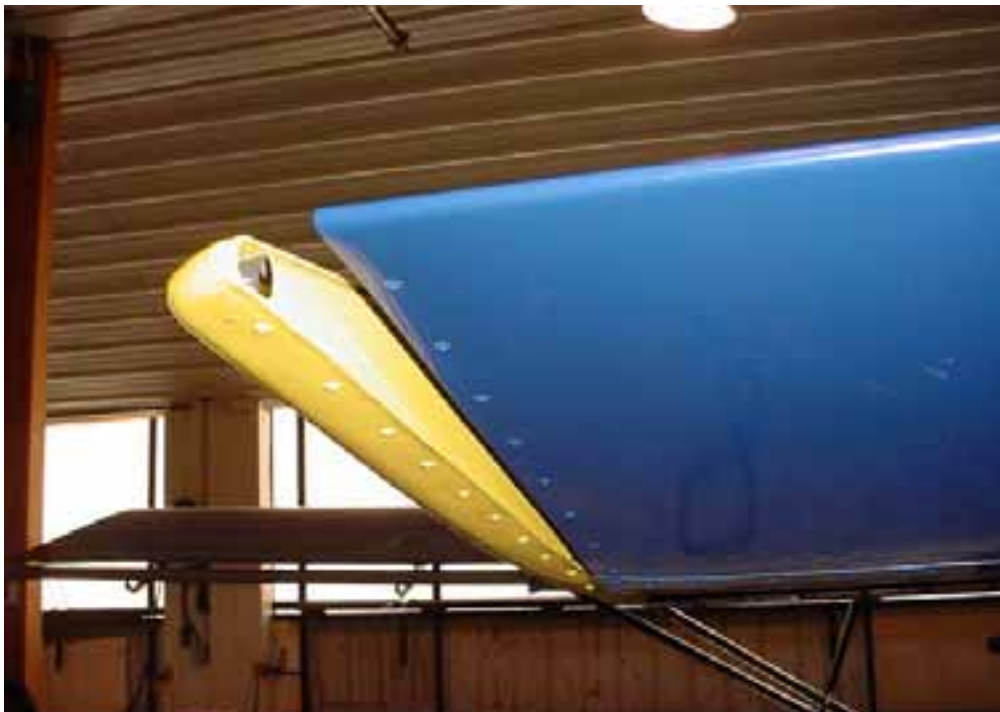
Acceptable misalignment between the left and right of the fiberglass tips and the elevator trailing edge.

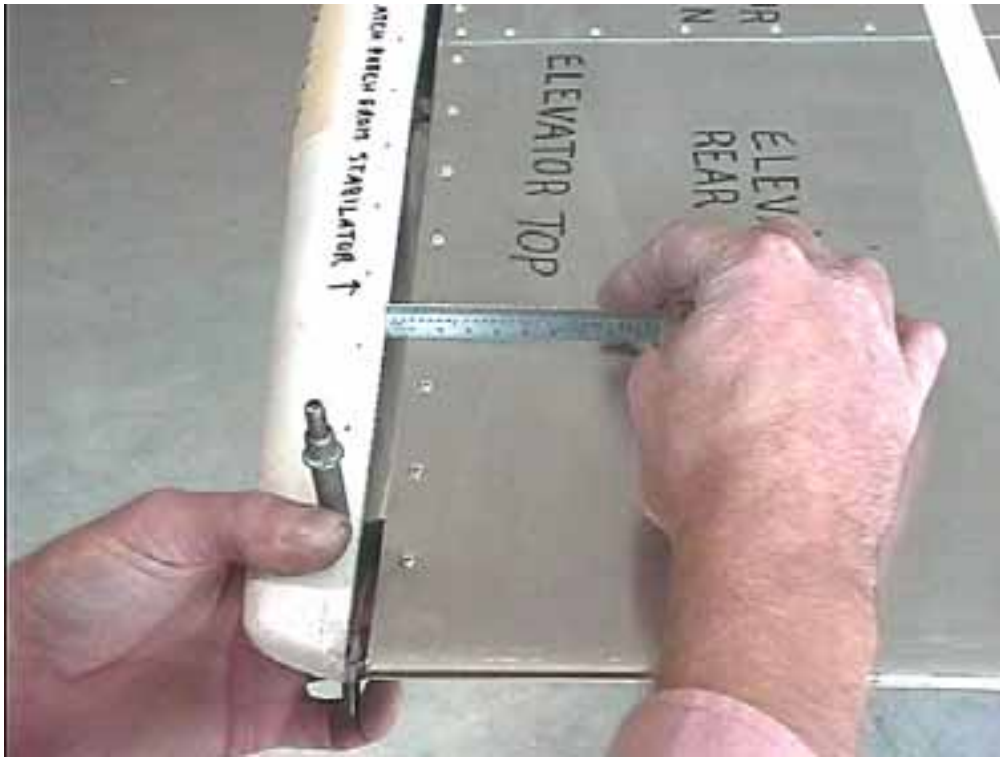
Keep the gap uniform - about 5 to 6mm is good.

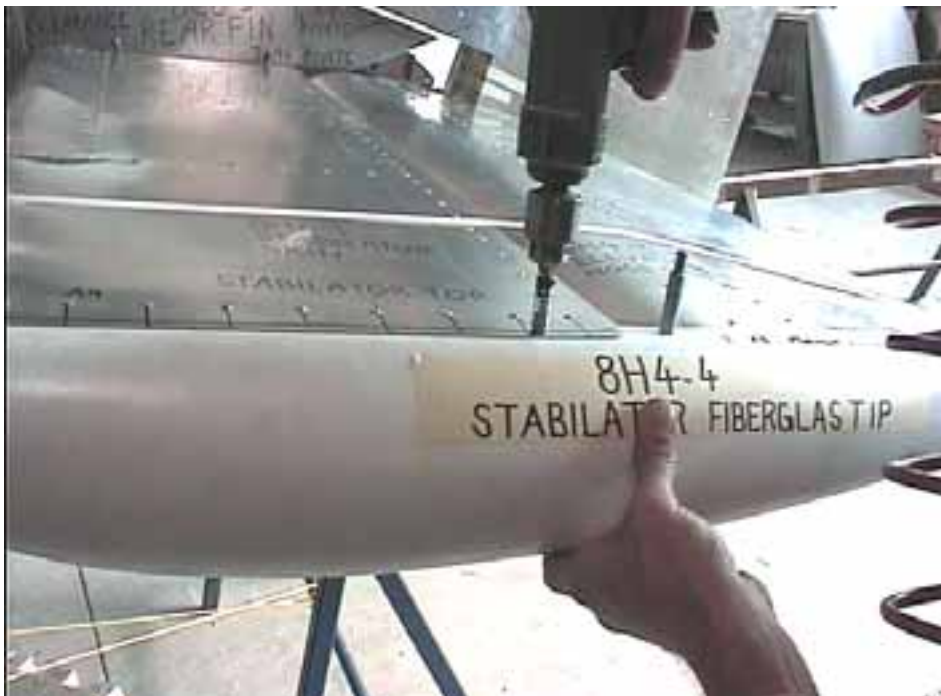
**A4 PITCH 40**  
8H6-3 into 8H4-4

Hold the tip in place and drill one hole at either end. Stand back and take a look if you are satisfied; continue drilling and clecoing the tip in place. Repeat for the other side of the horizontal tail.

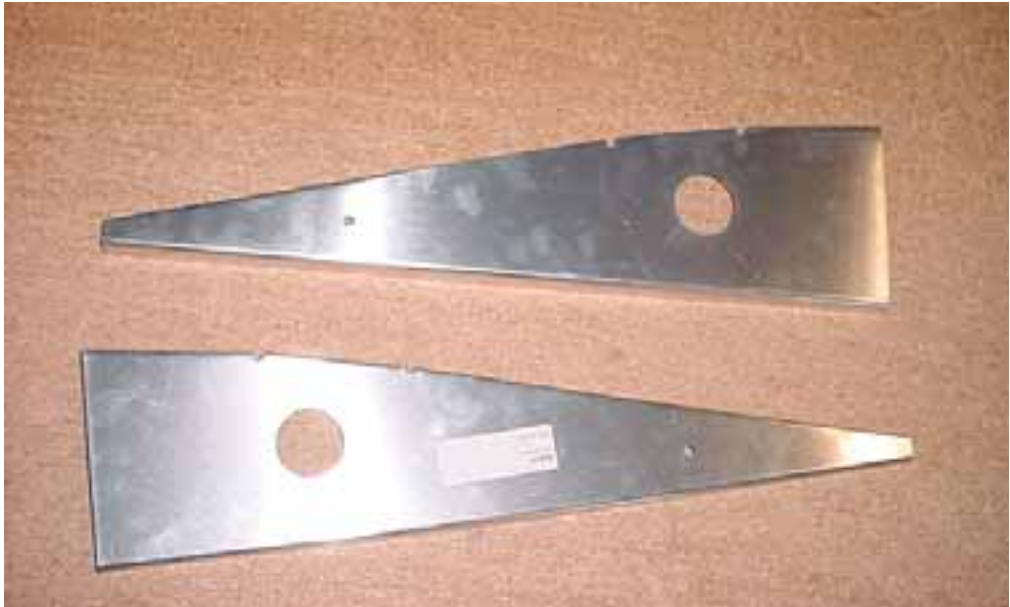
**TIP BACKING RIB**  
**8H4-5 qty= 1L +1R**

The tip rib.

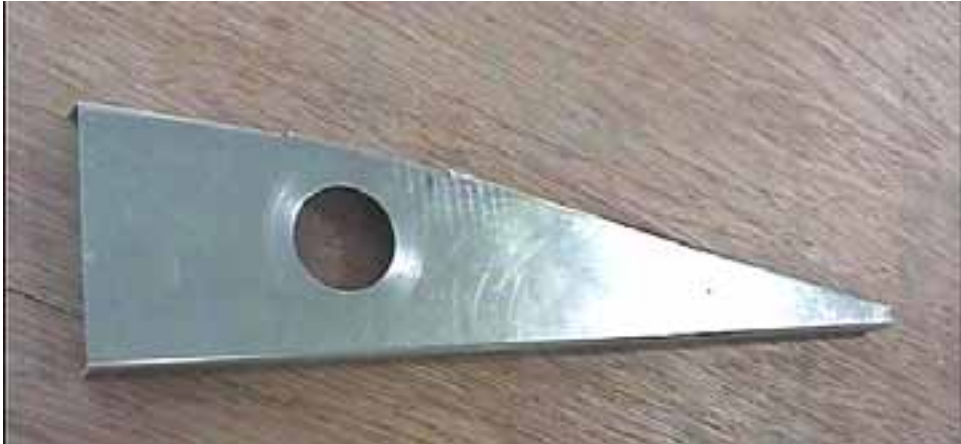
Tip rib with hole opened to 35 to 50mm to provide clearance for the elevator hinge ping and cotter pin.

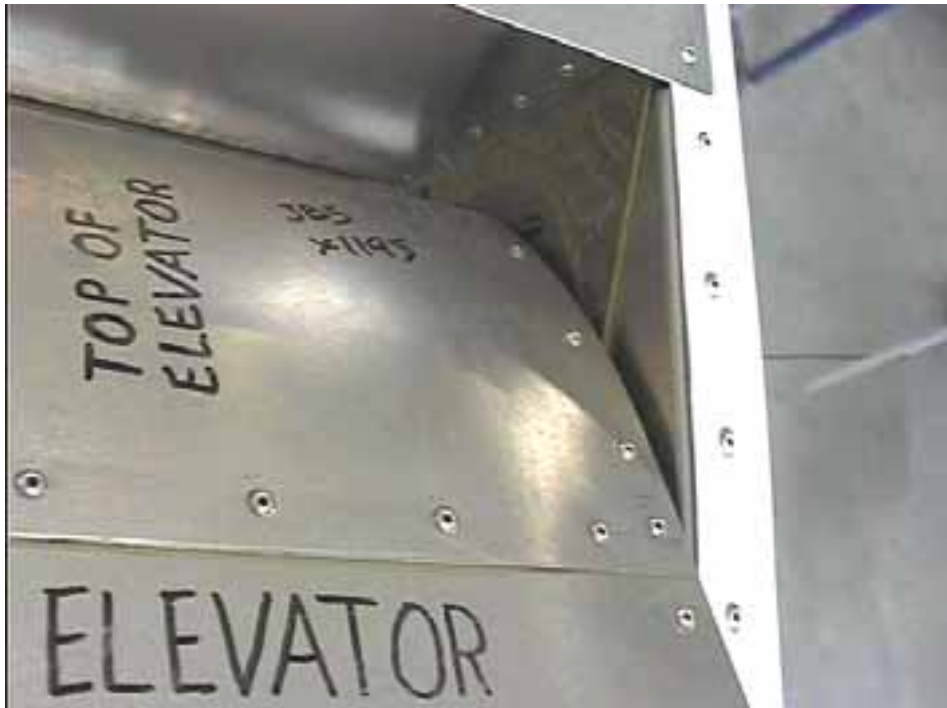
**A4 PITCH 40**  
8H4-4 into 8H4-5

Install the tip rib behind the elevator hinge.

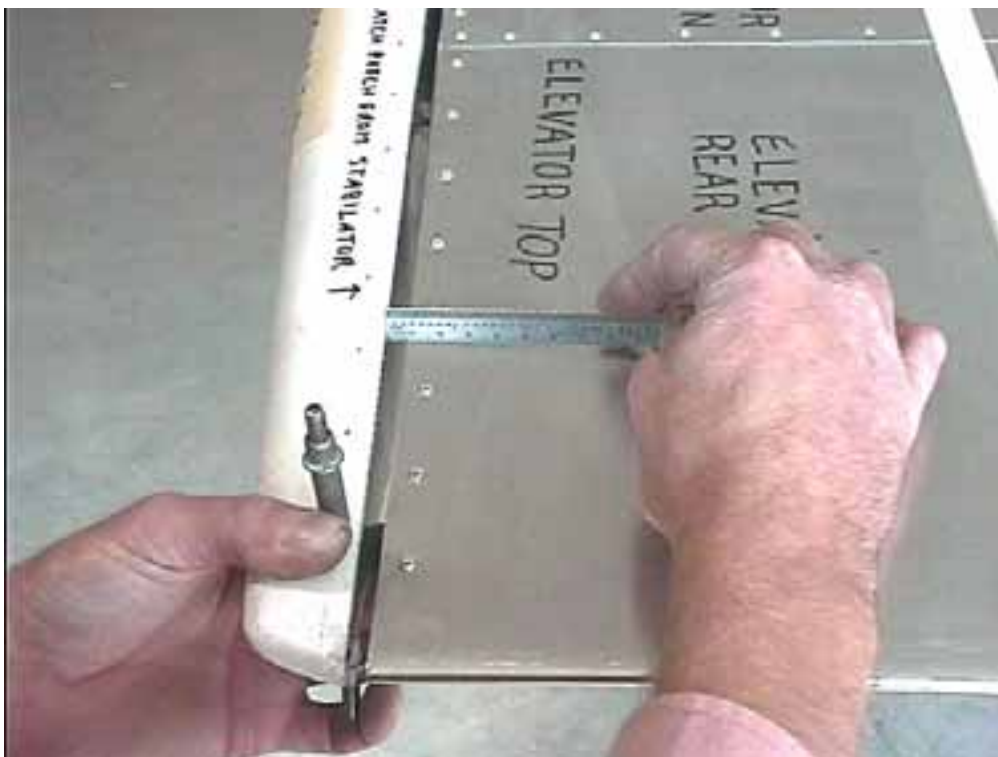
Extend the rivet pitch centerlines to the rear of the fiberglass tip.  
Drill and rivet the rib in place. Repeat the process for the other side.
